# DIAGNOSIS OF DAMP AND STRUCTURAL PATHOLOGIES IN A SAMPLE OF MUD HOUSES USING 3D SCANNING. CASE STUDY: A HOUSE IN THE KHANGUET SIDI NADJI KSAR, BISKRA, ALGERIA

House 10, a structure built against the retaining wall of the Ksar of Khanguet Sidi Nadji: Diagnosis of pathologies.

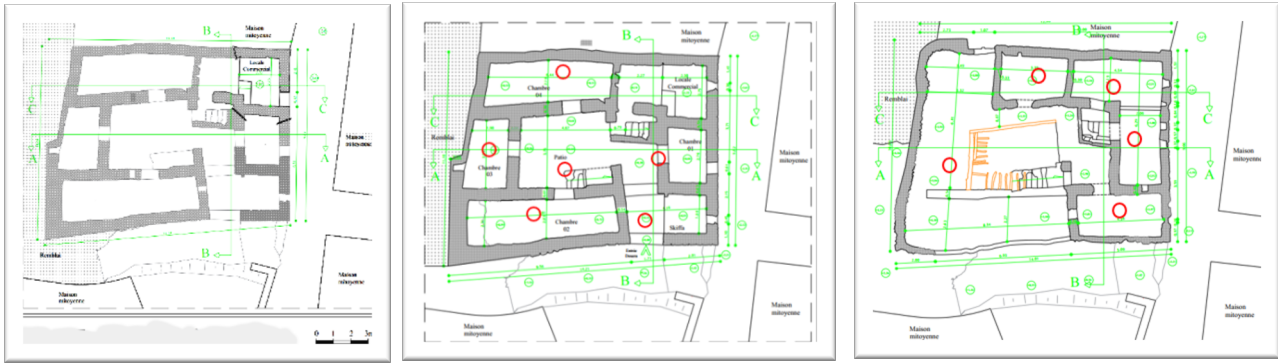
Fig. 8: Location of disorders (damp and structural) on the different levels of house 10. Plans based on the survey. Source: Authors.2024.

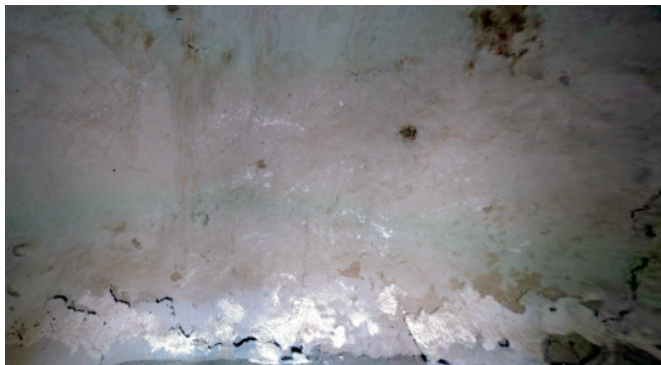
The damp conditions in this house can be observed at the -0.30m level of the ground floor. This level is in direct contact with the ground. The disorders observed in this case concern the stone material. Starting with capillary rise, which has caused erosion at the foot of the wall, in some cases leading to hollowing. We observed efflorescence caused by water from rising capillaries which, carrying mineral salts, rises to the surface of the walls and evaporates, leaving behind white crystals.

Photo 2 n°: Damage to the bottom of the wall caused by efflorescence, with detachment of the coating plaster.

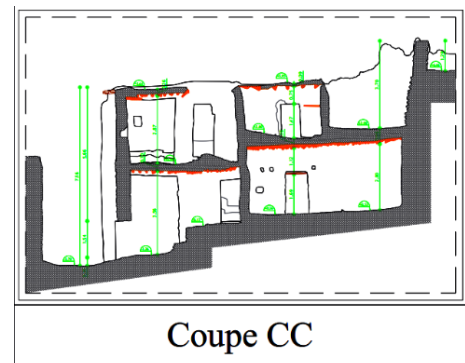
Fig. 9: Location of the disorder in section CC. Source: Authors.2024.

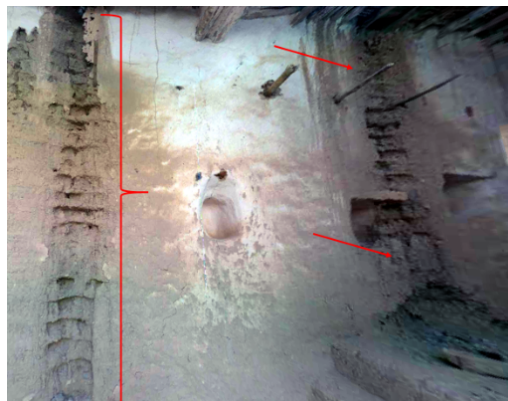
On the first floor, the majority of rooms show head erosion despite the presence of the floor. This phenomenon developed following rainwater infiltration through the roof. This disorder caused a number of wet patches, run-off, disintegration and hollowing out of the mud bricks, as well as erosion of the bottom of the wall.

Photo 3: Head erosion, hollowing of the mud brick and deterioration of the bottom of the wall caused by rainwater infiltration. Source : Authors .2024.

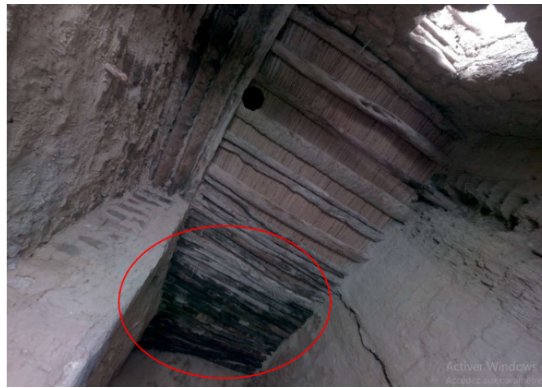
The floor of house 10 is made of palm and juniper wood. However, this floor has been the victim of a fairly serious disorder. The phenomenon is very noticeable in the commercial premises at -0.30m from the ground floor level and even in the ground floor bedrooms. Photo 128 shows the floor covering the ground floor. Part of this floor has been the target of rot due to the excessive humidity and lack of ventilation in this area. The rotting juniper wood has weakened the structure of the floor and made it unstable. This phenomenon is less visible on the side where the opening is located because of the good ventilation. In addition, termites and weevils are insects that feed on juniper wood. If infestations are not treated quickly, they can cause major damage.

Photo n°4: Development of mould on juniper wood caused by condensation, infiltration and poor ventilation. Source : Authors.2024.

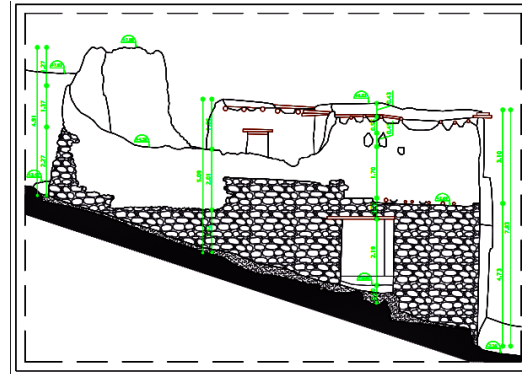
Fig. 11: House 10, north facade based on the survey. Source: Authors.2024.

The erosion at the head of the wall in house 10 is very noticeable in both the mud and stone sections. The unprotected walls have been altered, distorting the appearance of the wall, particularly on the north facade. The lower part of the building is in a good state of conservation, and erosion of the lower part of the wall is limited to rainwater run-off favoured by the slope of the land. There is little evidence of splashing.

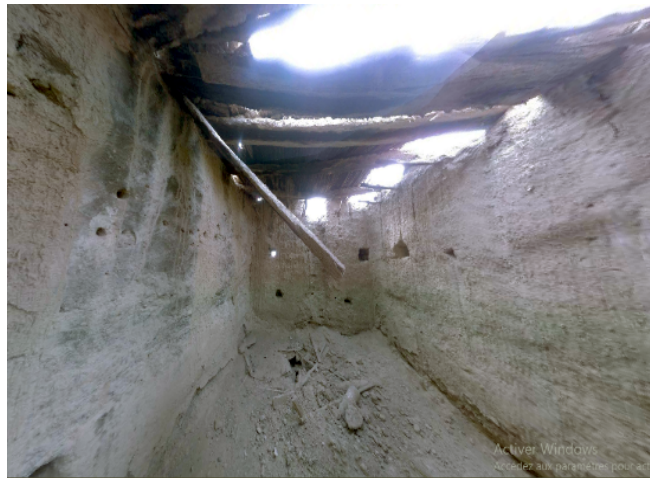
The infiltration of rainwater into the interior of house 10 has caused considerable damage. The floor has been destroyed and the rest of the juniper beams have disappeared. This disappearance can be explained by acts of looting that affected the entire Ksar. The black stains on the wall, caused by run-off water, are the colour of mould that has developed on the wood due to a lack of ventilation, as this space has no openings.

The winds also caused a great deal of damage. Loaded with sand, they have contributed to accelerating the effects of erosion.

*Photo 5: Damage caused by run-off, infiltration, internal condensation and wind. Source : Authors.2024.*

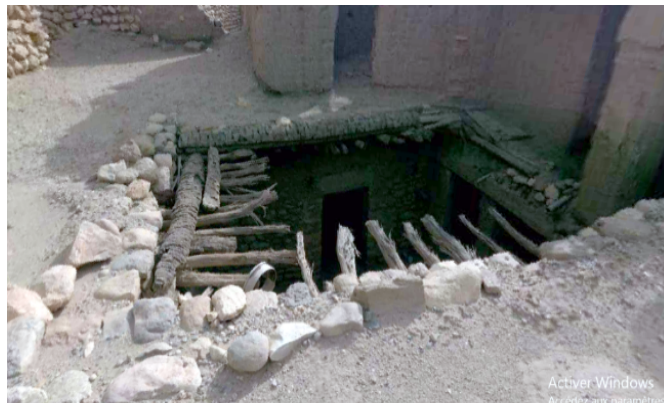
The disintegration of the elements making up the floor as a result of water and wind caused part of the covering of the first-floor passageway to be lost, which in turn deteriorated, revealing the protruding wooden bars. Photo 130 shows the appearance of the floor stones due to head erosion and the disappearance of the layer of earth covering the roof.

*Photo no. 6: Disintegration of roof components due to head erosion. Source : Authors.2024.*

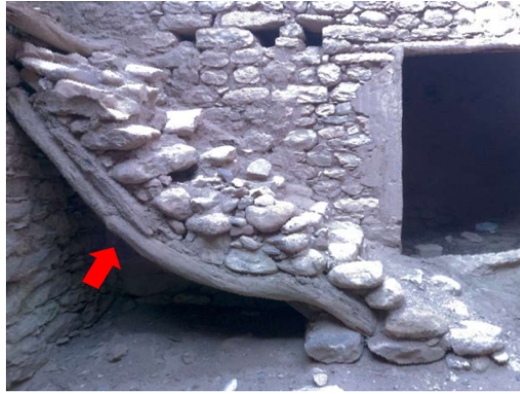
In photo. No. 7, we can see crumbling and erosion of the unbaked earth that joins the steps of the stone staircase due to direct exposure to humidity. A loss of material and structural strength, with bending of the palm wood beam that forms the framework of the staircase due to overloading caused by the destruction of the upstairs passageway.

In addition to this disorder, the staircase has been subjected to heavy loads and ground movement, causing subsidence and settlement. The steps have warped and cracked. The disintegration of the raw earth making up the staircase as a result of the impact of the collapses has caused the staircase to lose its cohesion, cracking and breaking.

Photo 7: Disorders diagnosed at staircase level in house 10. Source : Authors.2024.

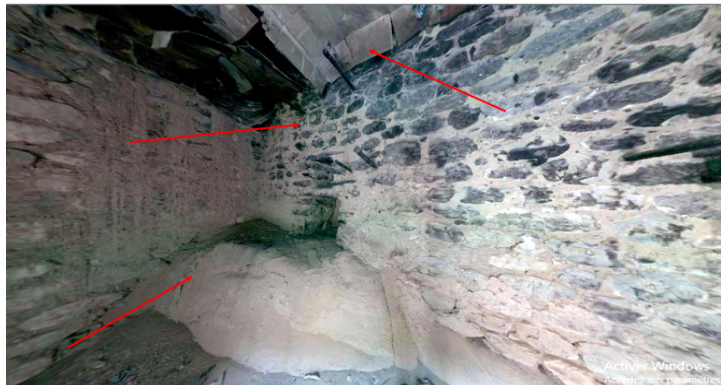
House 10 has a specific construction on the ground floor. One of the bedrooms is built on the retaining wall of the ksar (Photo 8). We did not diagnose any structural pathologies; on the contrary, the space is very well preserved, apart from patches of mould (condensation) caused by the infiltration of moisture through the floor. To remedy this problem, the occupants had used cardboard to protect themselves.

Photo 8: House 10 is built on the retaining wall of the ksar. Source : Authors.2024.

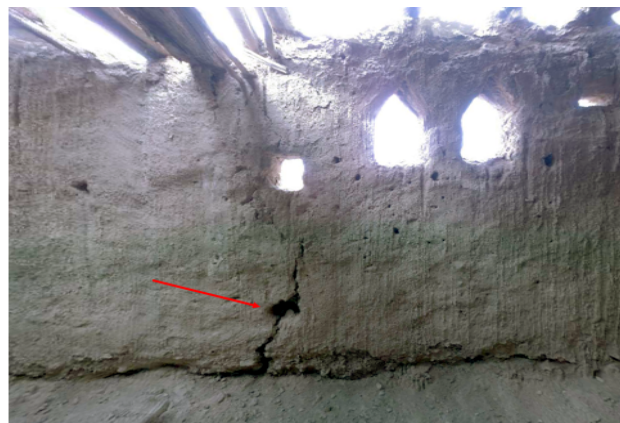
The diagnosis of the through crack in photo no. 133 is that the deformability of the foundations under the effect of the load thrusts of the facade wall has led to shear or flexural fractures depending on the size of the openings and the elasticity of the wall materials. In this case, the wall was added at a later date by the owner of house 10 on the first floor, with poorly spaced and randomly arranged openings of irregular dimensions.

Photo 9: Punching crack caused by poor load distribution on the wall. Source : Authors.2024.

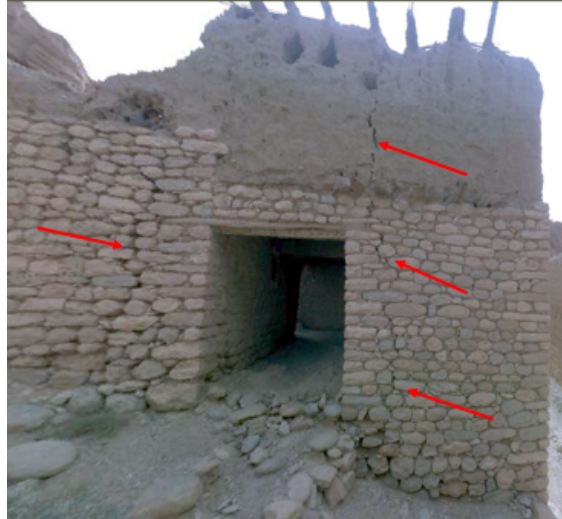
In the case of house 10, the pathology due to differential settlement of the foundations is different from that diagnosed on the caravanserai. Here, the long, through cracks have formed on both sides of the opening (the door) (photo no. 10). Although the house has a stone base wall, this has not prevented the formation of a heterogeneous load on the wall due to an extension to the first floor made by the owner of the house. The sloping ground also contributed to the disorder.

Photo no. 10: Differential settlement of foundations due to sloping ground and additional loads. Source : Authors.2024.

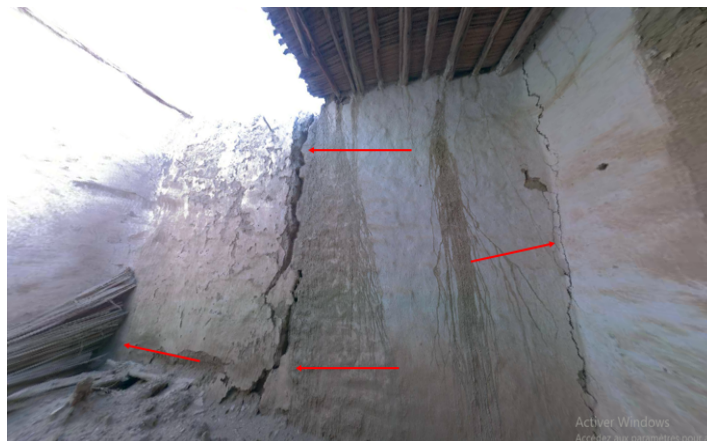
On the first floor, one of the pathologies visible in a space (bedroom) is very typical. We can see (photo no. 11) the corner crack is caused by the floor load and the poor junction of the transverse wall. The formation of this continuous, non-through fracture leads to a loss of continuity in the wall, which may reduce its monolithic nature.

This disorder has accentuated the appearance of the crack in the middle of the wall, which is continuous and through-going. This is due to rainwater infiltration, which has created a fault in the wall, as well as head erosion, causing the wooden beam and the wall to lose their support. The wind then completed the damage by tearing away the already damaged part of the floor.

Photo 11: Damage caused by overloading, damp and wind. Source : Authors.2024
