THE STATE ANALYSIS OF THE ANTI-EROSION INSTALLATIONS CARRIED OUT FOR THE PROTECTION OF THE CITY OF HASSI EL GHALA (WILAYA OF AIN TEMOUCHENT, ALGERIA) AGAINST FLOODS

The objective of the present work falls within this framework where we tried to make an analysis of the state and the effectiveness of some anti-erosion installations and in particular of the torrential correction thresholds installed since 1986 in a micro watershed located just at the upstream of the town of Hassi El Ghalla (wilaya of Ain Témouchent).

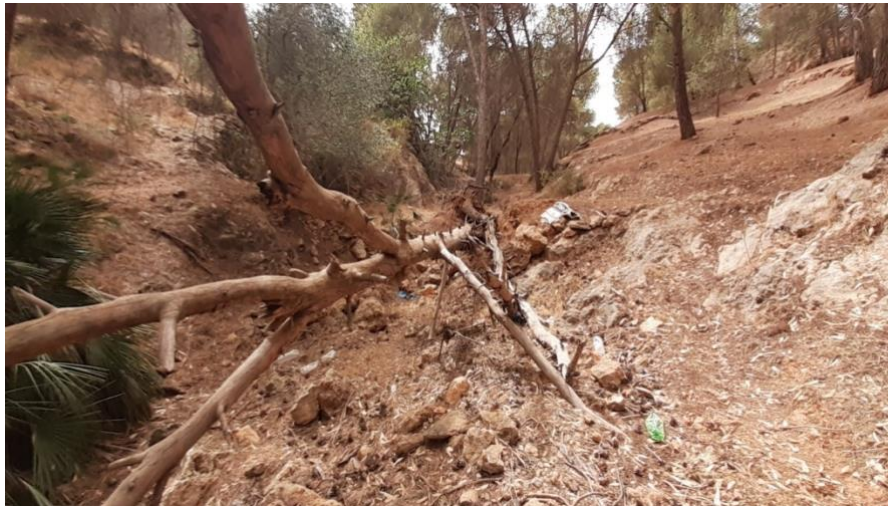
The latter is threatened by flooding since it is located downstream of a sloping watershed and with a significant water flow at the level of its main watercourse. We noticed that whole trees with their root systems have been uprooted, testifying to the importance of the flood flow that crosses the main watercourse as shown in figure 2.

Figure 2. Trees carried away by the flow of the flood on the main watercourse.

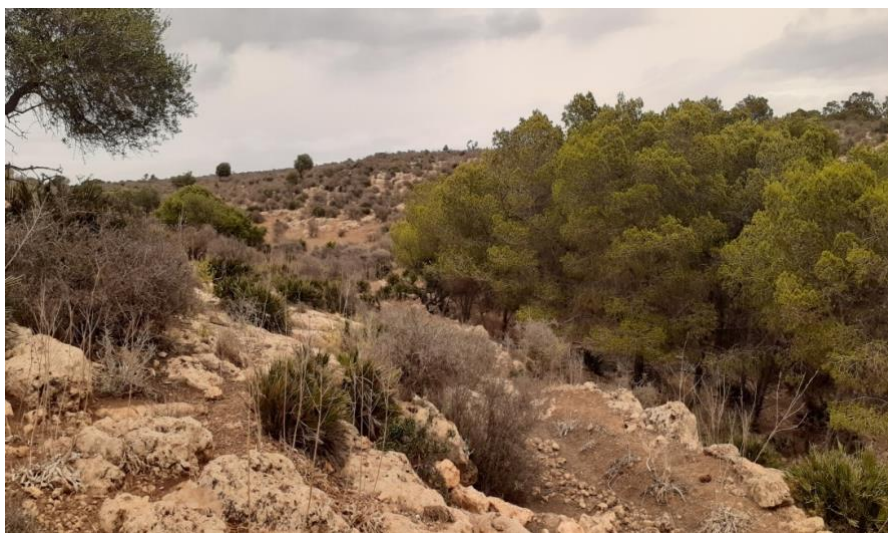
At the study station, we also observed outcrops of limestone rocks testifying to significant sheet erosion as shown in figure 3:

Figure 3. Rocky outcrop symptom of significant sheet erosion.

- The gravel load is very high on the surface of soils with outcrops of limestone rocks. This is a symptom of the dominance of sheet erosion;
- Linear erosion is less important despite a fairly high degree of slope, this is justified by the nature of the soils on site which are not very vulnerable to this type of erosion;

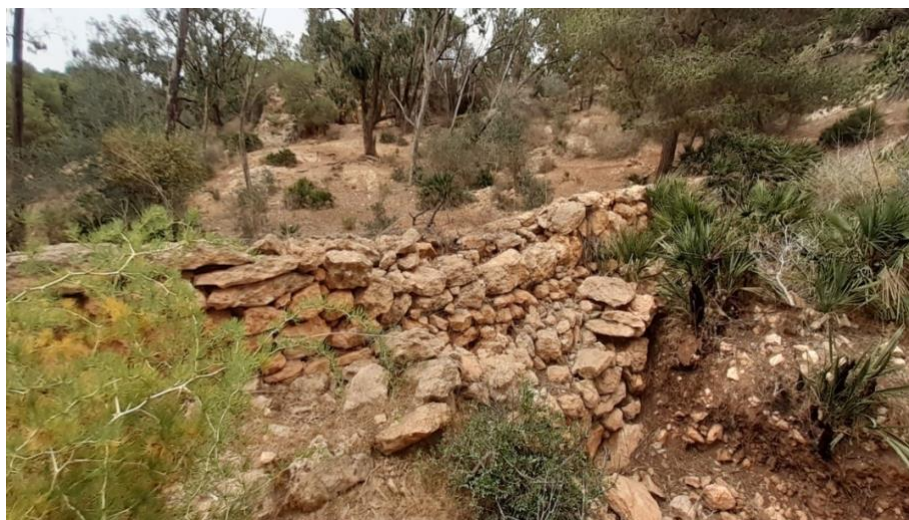
We also noted, during the prospecting on the ground, that the mesh of the gabion sills was cut and stolen in all the sills installed as shown in figure 4.

Figure 4. Stable gabion sill with cut and stolen mesh, good foundation and good anchoring.

- The instability of some gabion sills was mainly due to the total cutting of the fence, where some stones escaped from the sills by the floods;
- The instability of certain dry stone thresholds is due either to poor anchoring or a poor foundation;

- Maintenance of the torrential correction thresholds by replacing the stones carried away and raising them;
- The covering of the gabions again as far as possible by the metal mesh;
- The restoration also of the stones carried away at the level of the low walls;
- More vigilant control of overgrazing and fires;
- Promote the development of land and fruit plantations within the framework of rural development projects.

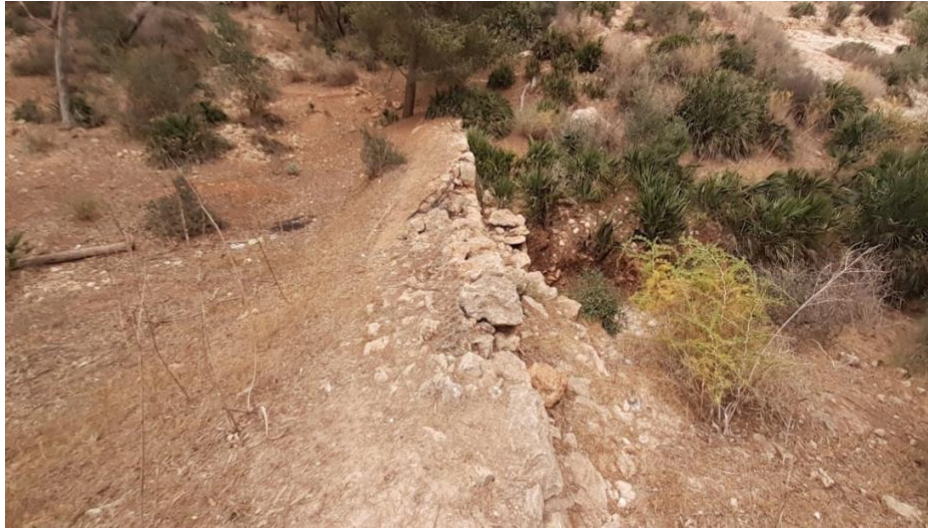
Vegetation cover is significant and the landfall upstream of each sill reached 100% in all sills as shown in figure 5.

Figure 5. Stable gabion sill with cut and stolen mesh with 100% landing.

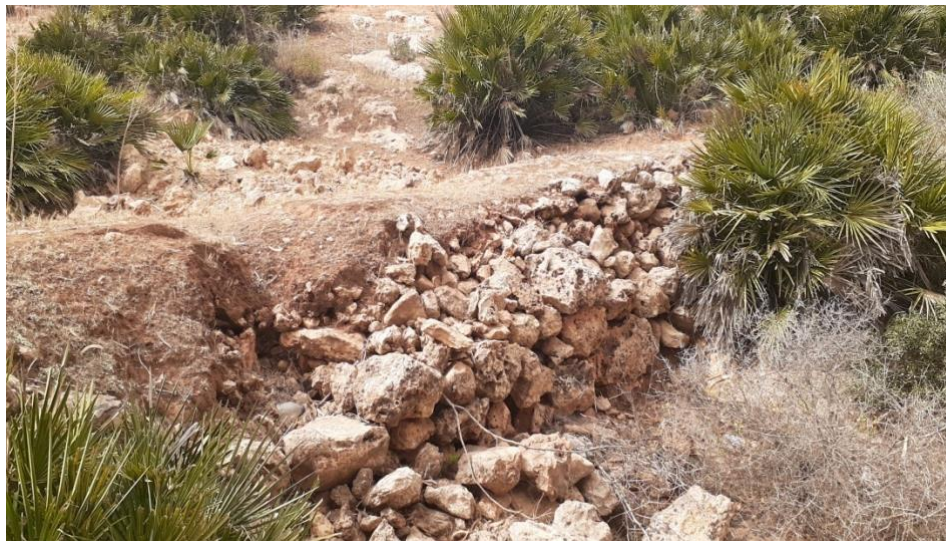
We also found that dry stone sills are less stable than gabion sills. This was due in most cases to poor anchorage either in the left or right side as shown in figure 6.

The fact of anchoring a consolidation dam in the side slopes and the bottom of the ravine considerably reinforces the stability of the structure. The anchorages consist of a trench 0.6 meters deep and wide dug across the channel. In case of excessive instability, it is increased to 1.2 or 1.8 meters (Burchard, 1980).

Figure 6. Unstable dry stone threshold on its left side due to poor anchoring.

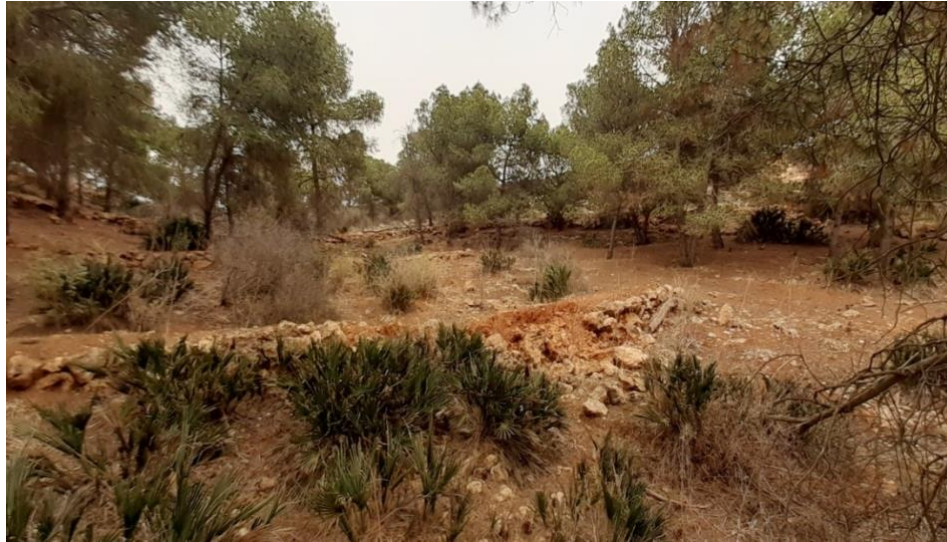
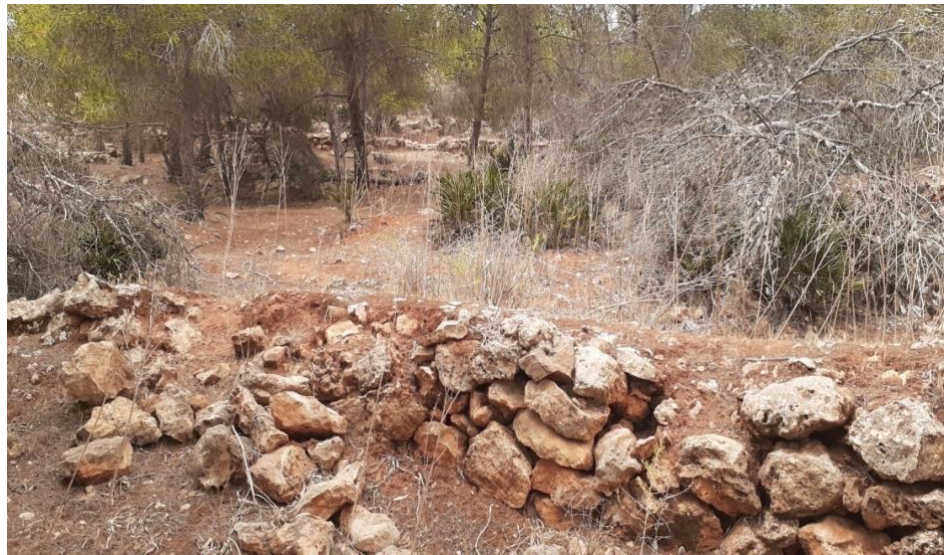
The upstream part of the micro-basin studied was cut into terraces supported by low walls to break the speed of water flow as shown in figures 7 and 8:

*Figures 7 and 8. Terraces with stepped low walls
(Some low wall stones were washed away by the force of the water current).*

- Some low wall stones were washed away by the force of the water currents;
- The plant cover is quite abundant with a natural Aleppo pine forest in good condition and some Eucalyptus trees;

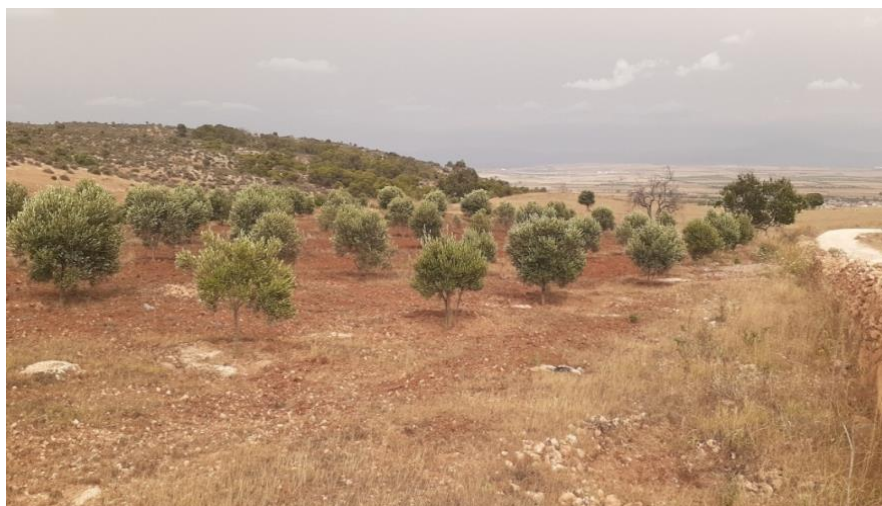
We observed in the studied area an olive tree plantation in the upstream part of the catchment area as shown in figure 9:

Figure 9. Olive growing upstream of the study area.
