ASSESSMENT OF THE STATE OF SOME ANTI-EROSION INSTALLATIONS IN THE DAIRA OF HONAINE (WILAYA OF TLEMCCEN – ALGERIA)

ABSTRACT

Water Erosion, Anti-Erosion Developments, Evaluation, Daira of Honaine, Wilaya of Tlemcen, Algeria

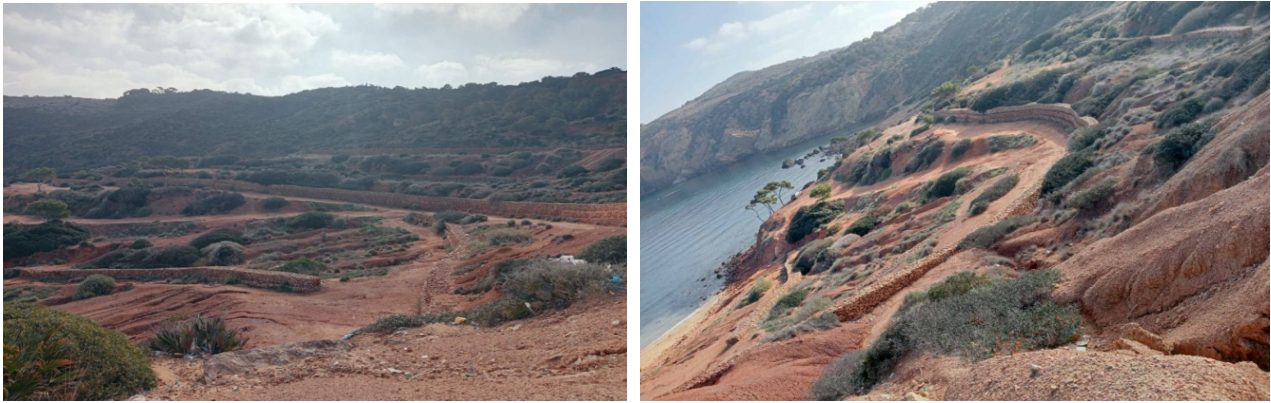
Photo 1 and 2: Station 1 of Sidi Driss beach protected against water erosion by gabions built in the form of walls

In the first station, gabions formed walls were built along the contour lines in 2003 and 2004 to protect the beach of Sidi Driss against the consequences of erosion (Photos 1 and 2). It is an unsupervised beach but it is very popular with summer visitors.

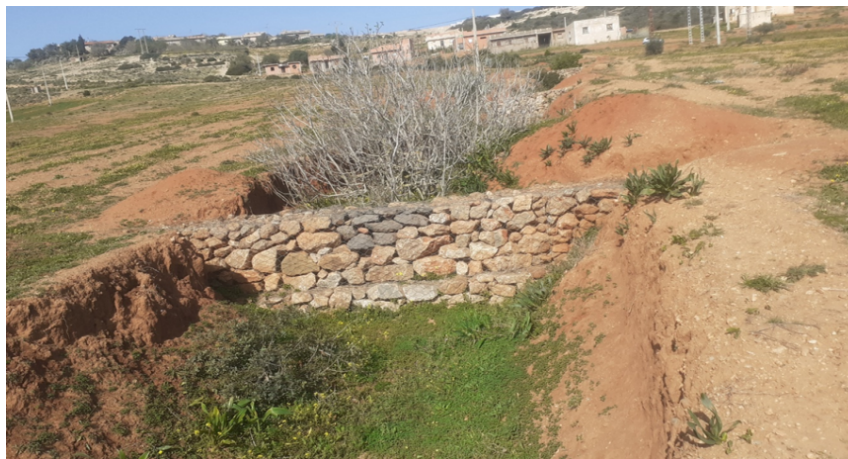
Photo 3: Station 2 of Ain Merika

In the second station, gabion thresholds were built in steps in the ravines in 2011, to protect agricultural land and the village of Ain Merika against linear erosion. This torrential correction action as a mechanical anti-erosion action as well as fruit plantations as a biological anti-erosion action were carried out within the framework of the Rural Renewal programs. The physical environment in the locality of Ain Merika is characterized by gentle relief. The dominant soil is clay-loam, which promotes the retention of water and essential nutrients for the vegetation. The climate is cool semi-arid, with an average annual rainfall of 350 mm. The local vegetation is composed of Thuya forests and rangelands where species such as Spiny Calycotome, Opuntia, Doum palm, Agave, Maritime Lavender and Rosemary grow. This plant diversity is well adapted to the semi-arid conditions of the region (MDP, 2011).

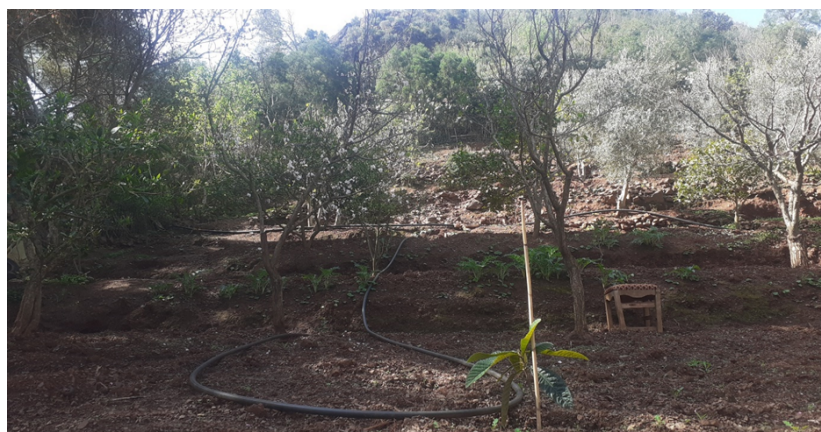
Photo 5: Station 5 located upstream of the town of Honaine

In the fifth station, sloping land was allocated to a farmer by the regional forestry administration. The latter, with a desire worthy of honor, arranged the space provided by terraces supported by low walls and planted with fruit trees (photo 5). These developments help protect the town and port of Honaine against flooding.

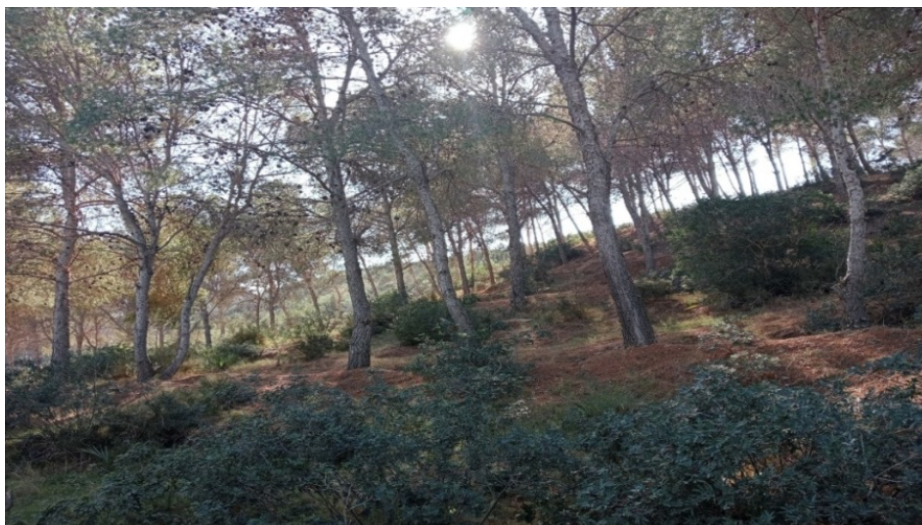
Photo 6: Ridges planted by the Aleppo Pine in station 4 of Ouled Sid Chikh

- in station 3, three (3) hectares of terraces were opened to protect agricultural land located downstream as part of the IRDP in the locality of Ouled Ben Ayad in 2009;
- and in station 4 in the locality of Ouled Sid Chikh, ridges were opened in 1979 as part of the DRS. The latter are planted by the Aleppo Pine (Photo 6).

- The ridges observed in station 4 of Ouled Sid Chikh are also in very good condition despite already 45 years of their installation. This is justified by their planting with the Aleppo Pine, which protected them and their undergrowth against the effects of runoff, particularly during exceptional heavy and/or long-lasting downpours.

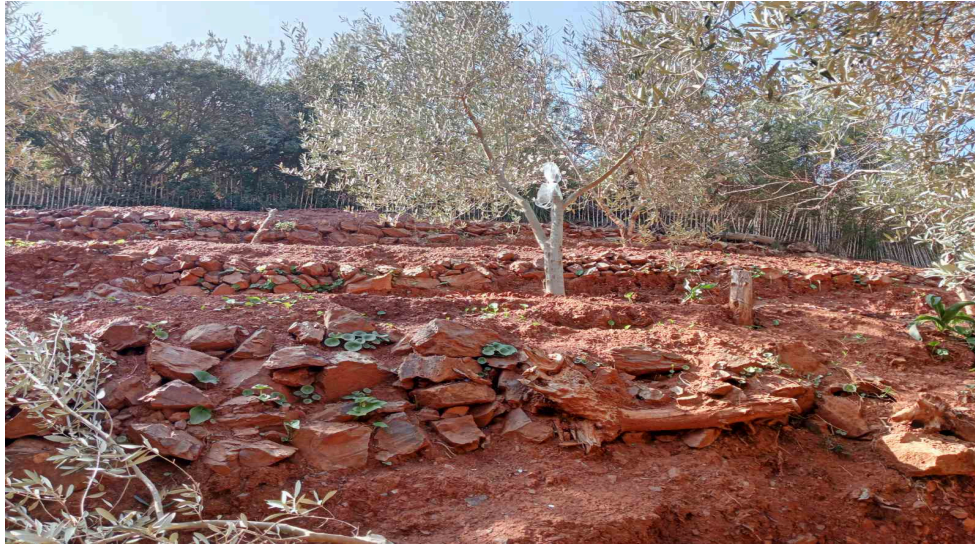
Photo 7: Terraces supported by low walls and planted with fruit trees in station 5 upstream of the town and port of Honaine

This technique was observed at station 5, upstream of the town of Honaine. Where a farmer, encouraged and supported by forestry agents from the Honaine district, was able to develop sloping land with terraces reinforced by low walls and fruit plantations (photo 7). This makes it possible to minimize solid and liquid transport resulting from the phenomenon of erosion which threatens the town of Honaine located downstream, by flooding and the port by siltation.

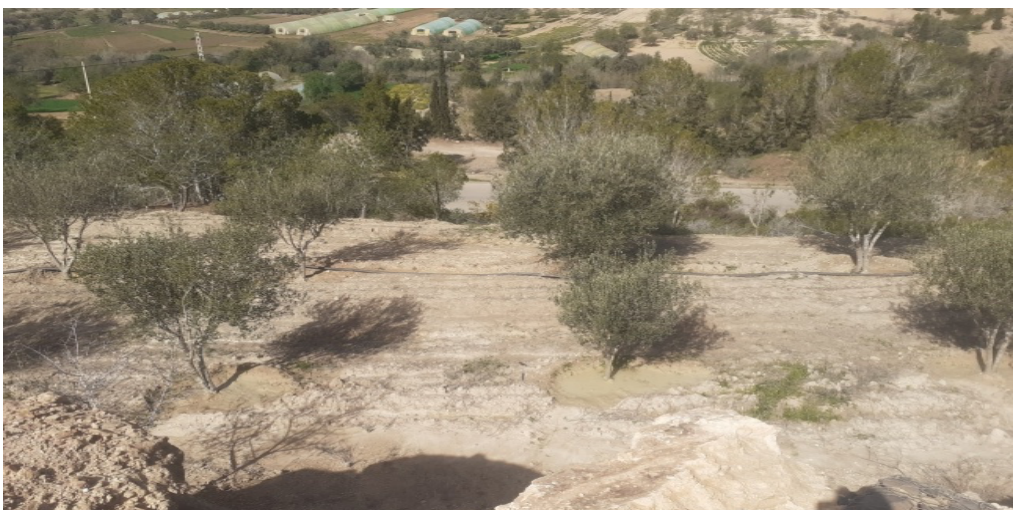
Photo 8: Olive growing in the Ouled Ben Ayad station

This biological action is quite present in the area studied. One hundred (100) hectares of fruit plantation were carried out as part of the Rural Employment Project “REP” in 2004. And it was also greatly favored in rural development projects from 2009, notably olive growing. As part of the IRDP, 22 hectares were planted with olive trees in the locality of Ain Merika (station 2) in 2011 and 16 hectares in the locality of Ouled Ben Ayad (station 3, photo8) in 2009.

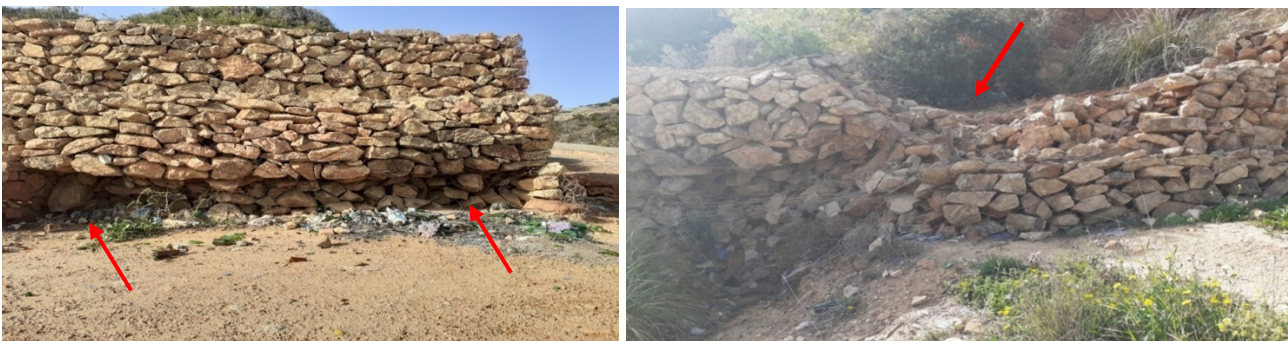
- the current state of the gabions in station 1, observed during field surveys, showed that the weirs were built according to standards. They are most stable and in good condition despite having been built 20 years ago and they have minimized the effect of erosion on the beach of Sidi Driss. But bad habits carried out by summer visitors and the neighboring population who frequent this unsupervised beach have been observed, in particular the cutting of the wire of the metal mesh for resale (photos 10 and 11). This offense leads to instability of the weirs following the movement of the stones which fill the gabion cages. Erosion is therefore accelerated (photo 12).

Photo 10 and 11: Cutting of the metal mesh leads to movement of stones and instability of the gabion threshold

The results obtained showed that most of the anti-erosion installations analyzed in the 5 stations in the study region are in very good condition. This demonstrates the perseverance of foresters, particularly in the creation of gabion thresholds and ridges. A remarkable and honorable desire of the region's farmers was also noted, by protecting the soil with fruit plantations and the opening of terraces. Only a few rehabilitations, notably in station 1 of Sidi Driss beach, are necessary for greater efficiency.

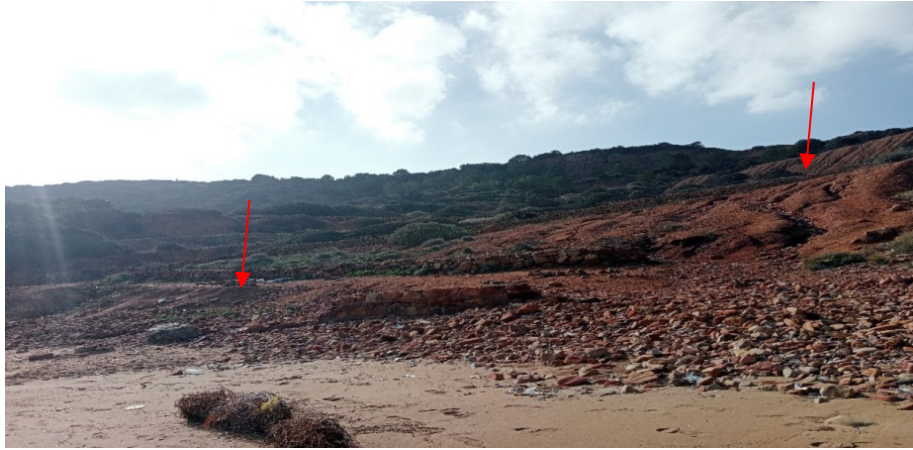
Photo 12: Acceleration of the erosion phenomenon following the instability of gabion sills

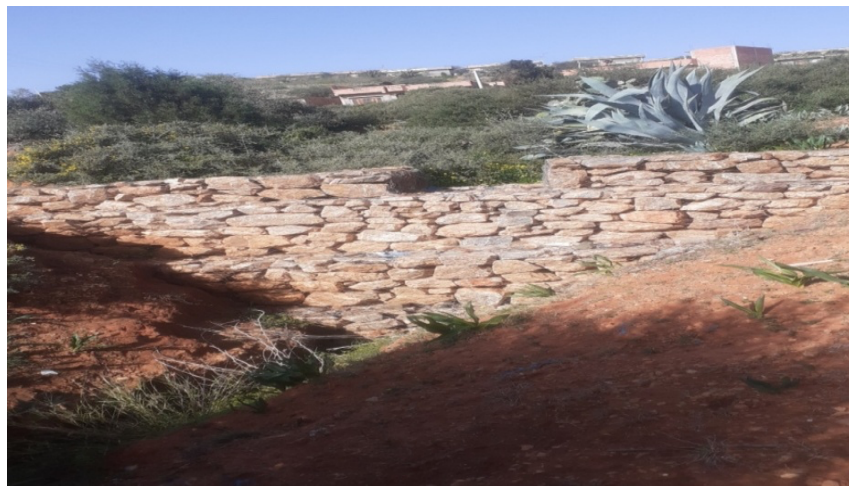
- the gabion thresholds observed in station 2 (photo 13) and station 3 (photo 14) are in very good condition, their stability is remarkable despite more than 10 years of their installation. This stability testifies to the perseverance of foresters in the stages of achieving these weirs. The latter protected agricultural land located downstream against flooding. Their stability can also be justified by the presence of a fairly dense plant cover next to other weirs. And unlike station 1, we did not observe the cutting of the metal fence in these stations, which affirms the awareness of the local population regarding the importance of these structures.

Photo 13: Stable gabion threshold with two cages and a rectangular spillway in the Ain Merika station

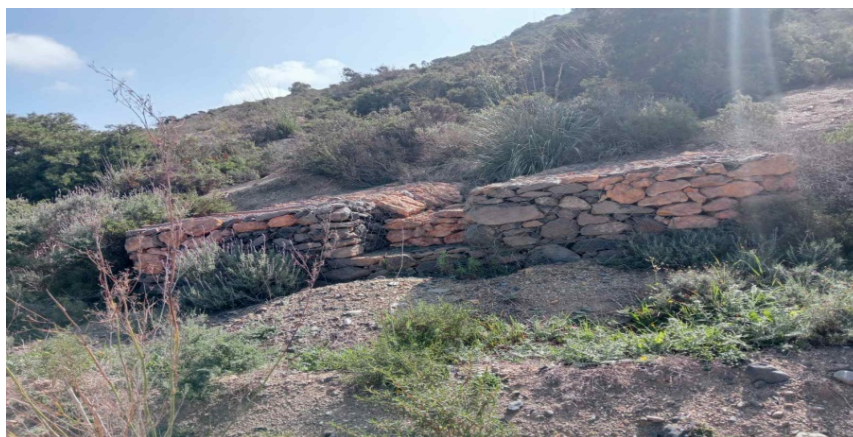
Photo 14: Stable gabion threshold in the Ouled Ben Ayed station

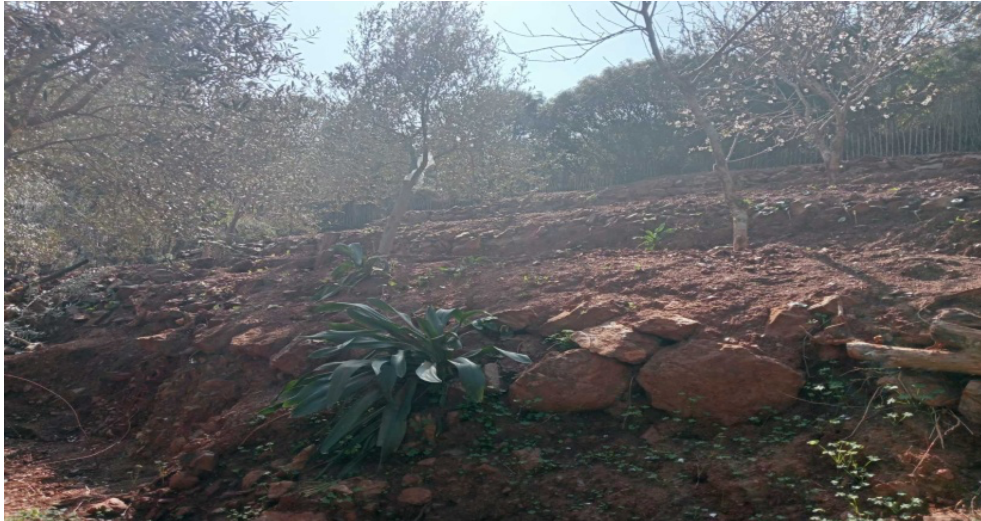
Photo 15: Low walls built in station 5

- The terraces supported by low walls and planted with fruit trees in the fifth station are also generally in good condition. Some low walls are poorly constructed (photo 15), this is justified by the lack of labor because the land is managed and operated by a single farmer.
