ARTICLE TITLE	3D LASER SCANNING AS A CRITICAL ARCHIVE: A MORPHOSTRUCTURAL REASSESSMENT OF THE MOSQUE OF THE DEY IN ALGIERS
----------------------	--

3D LASER SCANNING AS A CRITICAL ARCHIVE: A MORPHOSTRUCTURAL REASSESSMENT OF THE MOSQUE OF THE DEY IN ALGIERS

This article offers a critical reassessment of the Mosque of the Dey in Algiers, based on the cross-analysis of three sources: a three-dimensional survey conducted by terrestrial laser scanning (TLS) in 2019, direct in situ material observations, and Ottoman legal records transcribed by Albert Devoulx. Situated within a building archaeology framework, the study reconstructs the processes of assembly, reuse, and adaptation that governed the construction of this monument, regarded as the last major architectural achievement of Ottoman authority in Algiers. Three key areas are analysed in detail: the north-east wall, the qibla wall, and the minaret. The TLS survey reveals an asymmetry between the base and the upper section of the north-east wall, with irregular over-thicknesses and misalignments pointing to the integration of an earlier substructure. The qibla wall displays a subtle yet significant outward inclination in its uppe

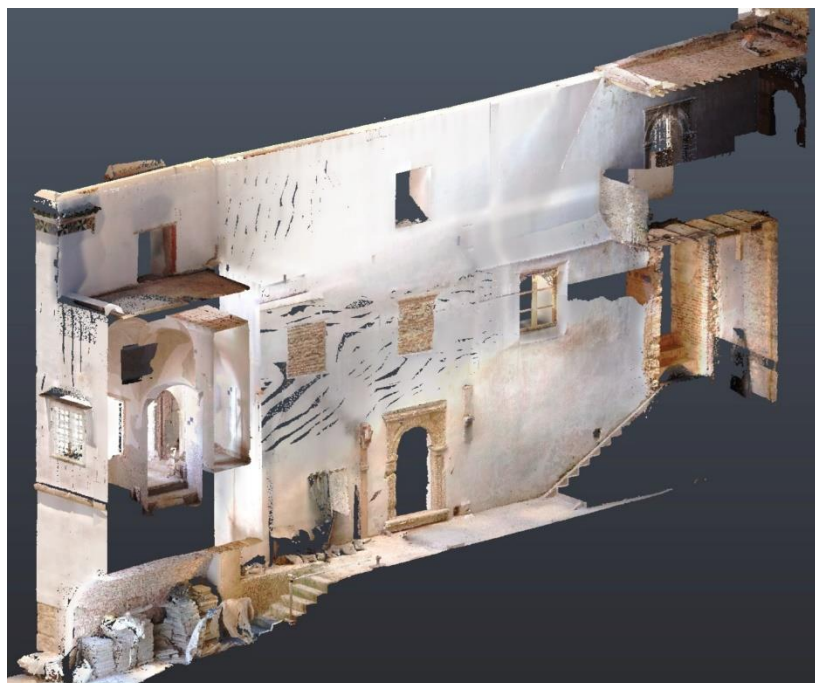
Fig. 4. Point cloud – view of the patio

Their height corresponds to that of a former, now disappeared, floor. This level aligns with the offsets of the mosque wall, suggesting that a transverse floor once connected the two entities. The presence of openings in the mosque, located below this level, indicates that the space was then open, playing a fundamental role in the lighting and ventilation of the prayer hall from the north-east.
