# DIAGNOSIS OF DAMP AND STRUCTURAL PATHOLOGIES IN A SAMPLE OF MUD HOUSES USING 3D SCANNING. CASE STUDY: A HOUSE IN THE KHANGUET SIDI NADJI KSAR, BISKRA, ALGERIA

House 10, a structure built against the retaining wall of the Ksar of Khanguet Sidi Nadji: Diagnosis of pathologies.

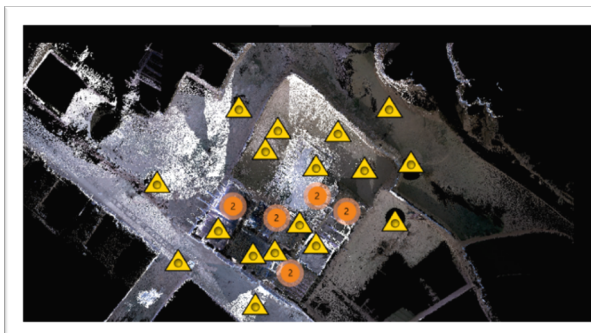
Fig. 7: Plan view of house 10 surveyed with Jet Stream Viewer (location of survey stations and diagnosis). Source : Authors.2024.

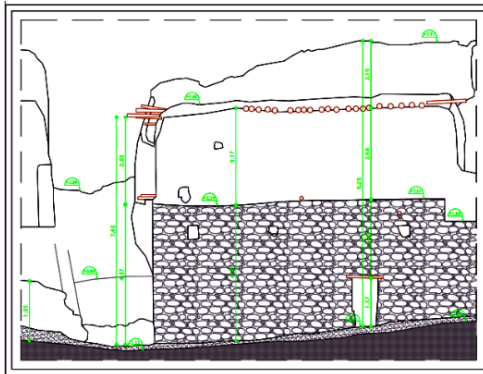
The erosion at the head of the wall in house 10 is very noticeable in both the mud and stone sections. The unprotected walls have been altered, distorting the appearance of the wall, particularly on the north facade. The lower part of the building is in a good state of conservation, and erosion of the lower part of the wall is limited to rainwater run-off favoured by the slope of the land. There is little evidence of splashing.

Fig. 10: House 10, south facade based on the survey. Source: Authors.2024.
