ARTICLE TITLE	COLONIAL RURAL BUILDINGS IN ALGERIA: FROM DISUSE TO VALORIZATION, CASE STUDY OF THE GUELMA REGION
AUTHOR(S)	Fouzia Fareh, Djamel Alkama
ARTICLE INFO	Fouzia Fareh, Djamel Alkama. (2024) Colonial Rural Buildings in Algeria: From Disuse to Valorization, Case Study of the Guelma Region. <i>International Journal of Innovative Technologies in Social Science</i> . 3(43). doi: 10.31435/rsglobal_ijitss/30092024/8229
DOI	https://doi.org/10.31435/rsglobal_ijitss/30092024/8229
RECEIVED	14 August 2024
ACCEPTED	27 September 2024
PUBLISHED	29 September 2024
LICENSE

COLONIAL RURAL BUILDINGS IN ALGERIA: FROM DISUSE TO VALORIZATION, CASE STUDY OF THE GUELMA REGION

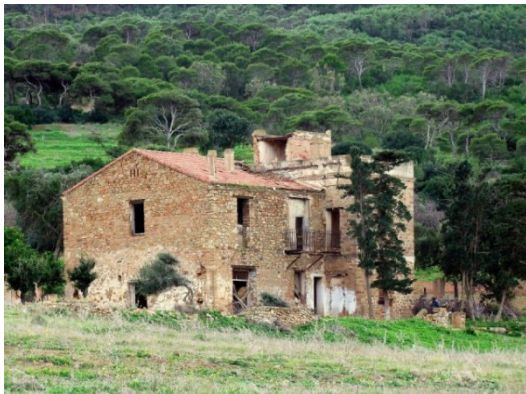
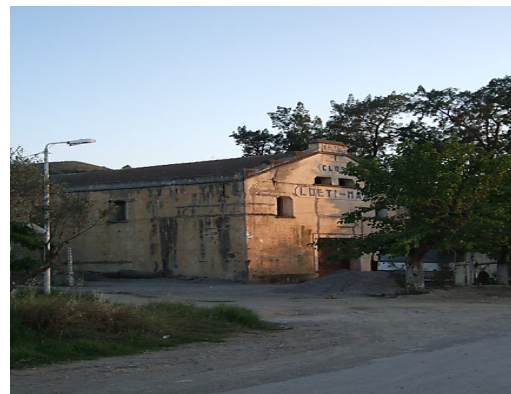
Figure 1. (Left) Old colonial farm in a state of disrepair built in 1921. (Right) Abandoned colonial hangar in Les Issers by Jaque Regnier in El Marsa. (Source: author).

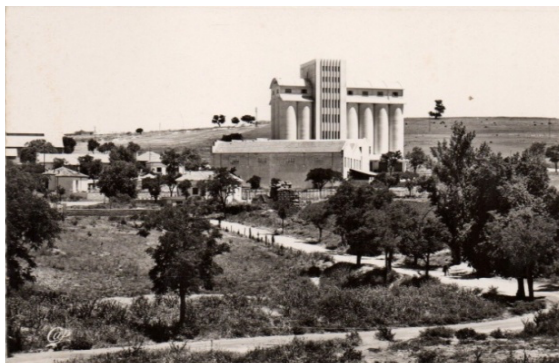
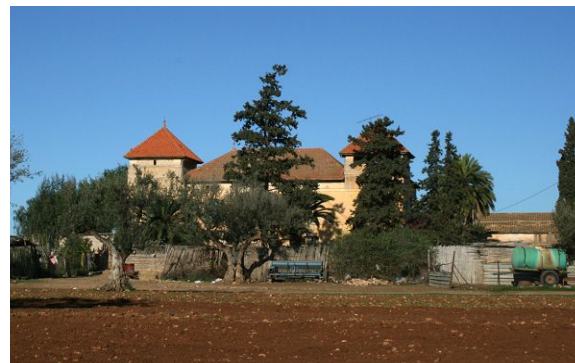
Figure 2. (Left) Colonial operational dock silo on the side of Frenda (Tiaret). (Right) Colonial farm in the vicinity of Hennaya, repurposed for residential use after rehabilitation. (Source: author).

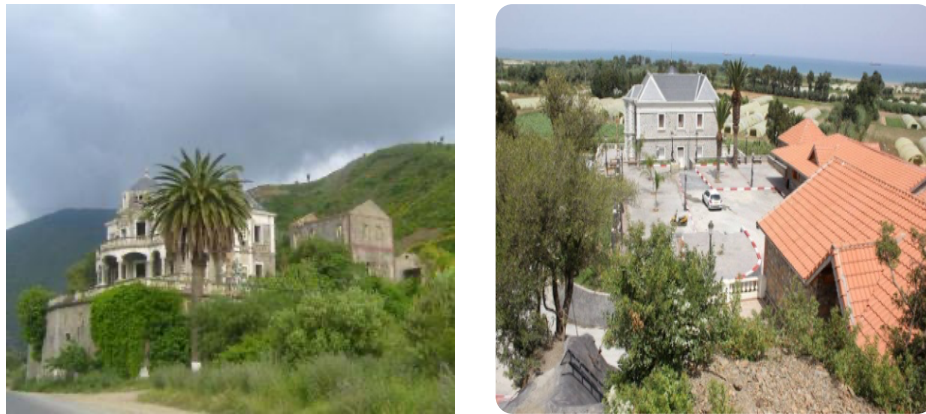
Figure 3. Reconversion of a colonial rural farm, Château de la Comtesse, into a youth hostel in Bejaia. (Source: author).

Alternative or green tourism is a recognized sector that serves as a promotional tool for regions endowed with tourism potential intertwined with their natural and architectural heritage (Richards, 2000). This heritage can be harnessed as a catalyst for wealth creation and local development while concurrently preserving the essence of the heritage itself. This form of tourism actively engages local inhabitants in the tourism project lifecycle, emphasizing respect for local communities, cultures, and the environment. Rooted in the principles of alternative tourism, values such as equitable resource distribution, a profound connection to heritage, and a harmonious relationship with nature and the surroundings epitomize a solidarity-driven ethos (Fairclough, 2008). Green tourism, diverging from the conventional supply-demand model, strives to forge enduring bonds between tourists, the region, and the local populace. The revitalization of rural structures into lodging options like gîtes, inns, bed and breakfasts, or hotel establishments, complemented by the natural landscape, can instigate a vibrant tourism ecosystem for local residents and communities. This transformation can further be enriched by the promotion of local artisanal products. This progressive approach, mirrored in tourism development strategies overseas, is beginning to resonate positively in Algeria, exemplified by initiatives like the restoration project of a colonial castle, the Château de la Comtesse, in the northern region of the country.

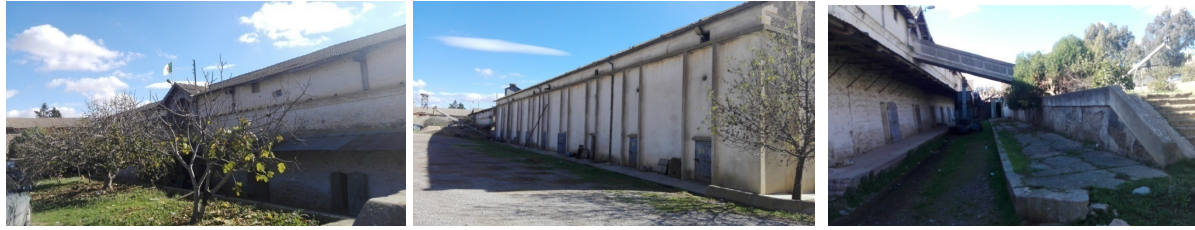
*Figure 4. The dock's exterior shows mostly intact buildings with minor damage.
(Source: author).*

This dock belonged to the agricultural group Jacky, and its construction project was initiated in the mid-19th century, along with that of the village church. It is a structure comprised of three large buildings spread over an area of approximately three hectares. Each building is unique in its characteristics and surroundings, yet together they form an inseparable whole. These buildings house warehouses and facilities primarily used for storing wheat before transferring it to other silos for milling. The dock has a capacity of 100,000 quintals of wheat, grains, and legumes.

In general, the Ain Regada dock does not appear dilapidated, except for the front facade of the building constructed initially. The other buildings are well-preserved, with only minor localized damages to the plaster and occasional tile loss on the roofs. These colonial warehouses and stores stand out not only for their morphological and spatial aspects but also for their refined and beautiful architectural detail. Additionally, they feature an ingenious wheat circulation system that demonstrates an ancient yet effective industrial process.

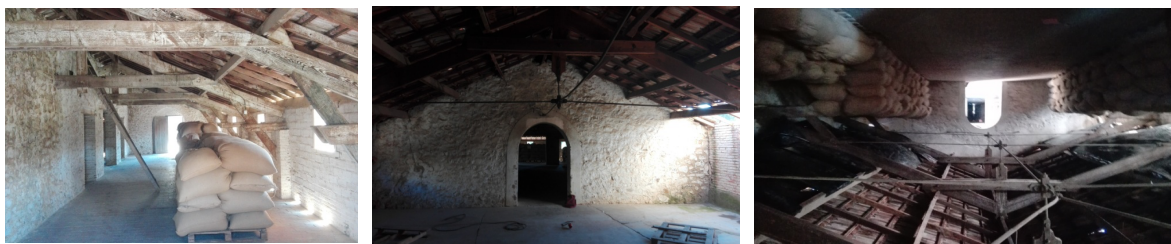
*Figure 5. A well-preserved state inside the warehouses with the wooden framework in good condition.
(Source: author).*

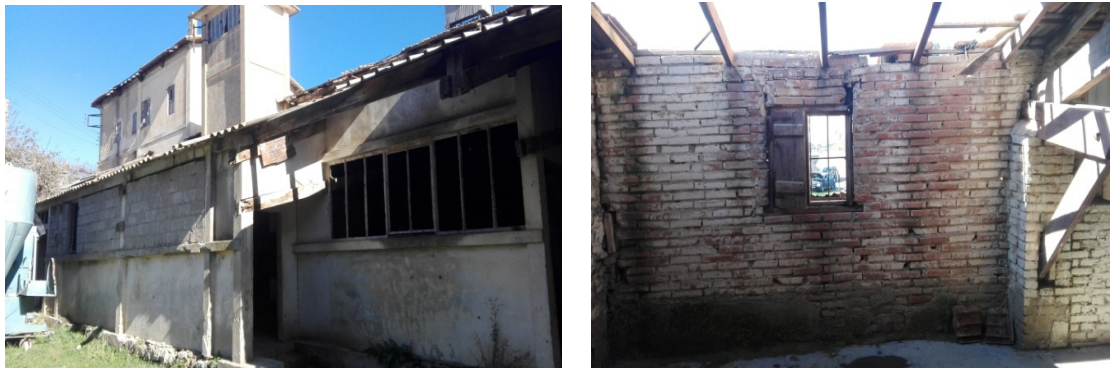
Figure 6. Temporary intervention by unskilled labor and inadequate materials in one of the buildings of the dock. (Source: author).

If this project has endured until today, it is due to the ingenuity of its construction technique, giving the impression that it was designed to defy time. The refinement of its architecture, combined with the precision of its operation and the solidity of its structure, all blend into a rural landscape that transports the observer to a timeless atmosphere. While the dock has not undergone any official interventions, partial restoration modifications have been observed, initiated by the site's users. For example, filling in falling walls with hollow bricks, using zinc instead of lost tiles for roofing, applying lime wash over the old plaster, and devising a wheat pumping method that alters the traditional, yet more effective and original, setup.

It has been noted that resorting to such materials to refurbish a part of the building has more often distorted its aesthetic appeal rather than enhancing it. It is important to understand that intervening randomly and personally on this heritage risks losing the authenticity of each structure. Instead, its

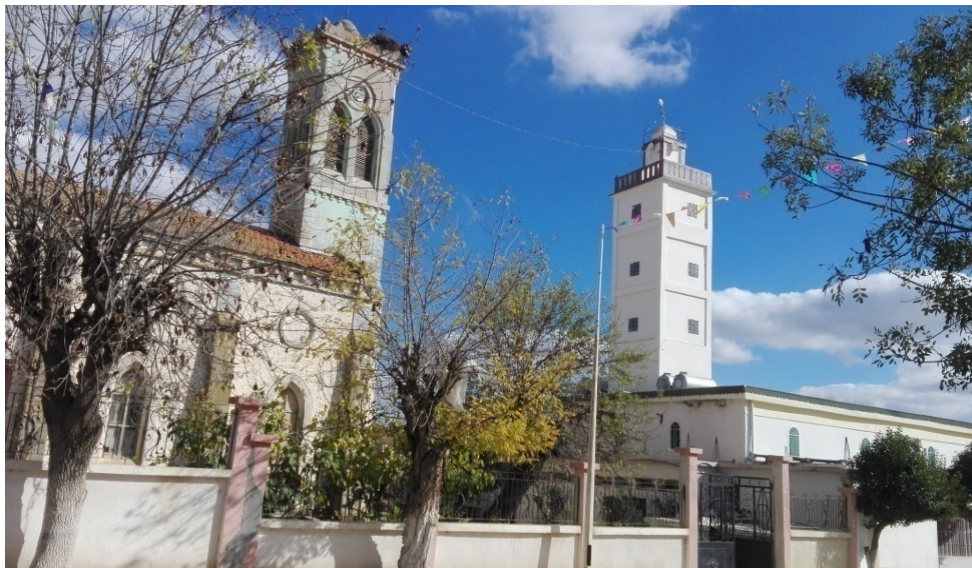
Figure 8. The church and the mosque when the old harmonizes with the new. (Source: author).

The use of the existing building as an essential element of the extension project, the placement of the new mosque next to the church, and the design of its minaret to mirror the old bell tower have ensured a certain coherence between the old and the new structures.

The church alongside the new mosque exemplifies a model of functional integration, creating a harmonious union between two buildings of different morphological, architectural, and ideological styles but with complementary functions. Together with the other buildings, they form the core of a small Islamic center employing about ten people and meeting an increased demand for religious practice and education.
